Debris/Ice/TPS Assessment and Integrated Photographic Analysis for Shuttle Mission STS-57

July 1993

Gregory N. Katnik
NASA/Kennedy Space Center

DEBRIS/ICE/TPS ASSESSMENT
AND
PHOTOGRAPHIC ANALYSIS
OF
SHUTTLE MISSION STS-57

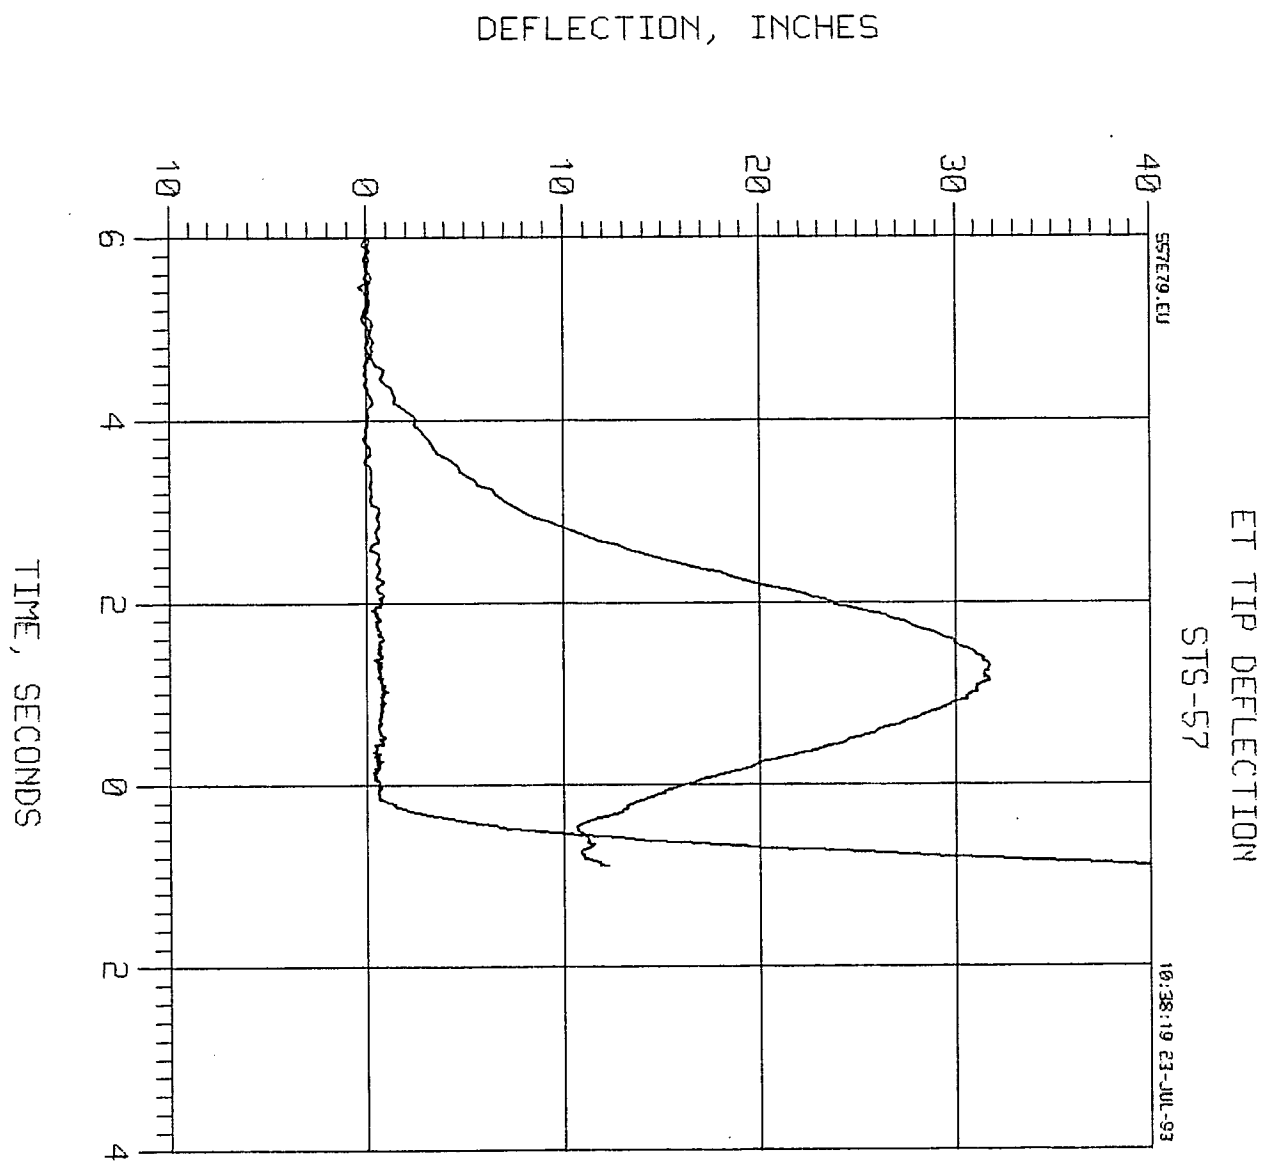
Maximum ET tip deflection for this mission was determined to be approximately 32 inches. Figure 5 is a data plot showing the measured motion of the ET tip in both the horizontal and vertical directions. These data were derived from camera E-79.
